# Evaluating Integrity of Storage Tank Bottoms based on Advanced MFL/ET Scanning: Use Case in Kazakhstan

Daniyar A. Ualiyev<sup>1</sup>, Abdugaffor Mirzoev<sup>2</sup>

## ABSTRACT

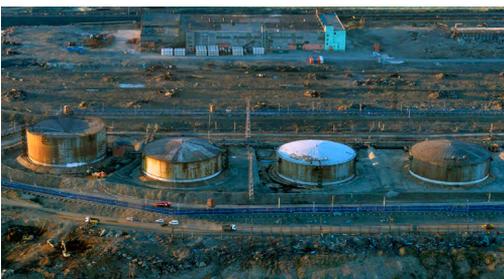
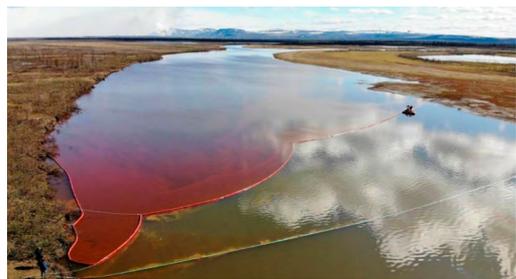
**Figure 2. Environmental Impact of the Storage Tank Failure at the Norilsk Power Plant**  
a) Collapsed Storage Tank at Norilsk Power Plant; b) Aerial View of the Contaminated River

integrity management is the Norilsk disaster of May 2020. As shown on Fig. 2 a fuel storage tank at a power plant collapsed, releasing over 21000 tonnes of diesel into nearby rivers, ultimately reaching the Arctic Ocean. The incident, attributed to structural failure caused by permafrost, resulted in severe environmental damage and costly remediation efforts. The cleanup efforts were extensive, and Nornickel, the company responsible, was fined approximately \$2 billion by the Russian government [1, 2]. This disaster highlighted the critical need for proactive inspection, predictive maintenance, and adaptation to evolving environmental risks to prevent similar failures.

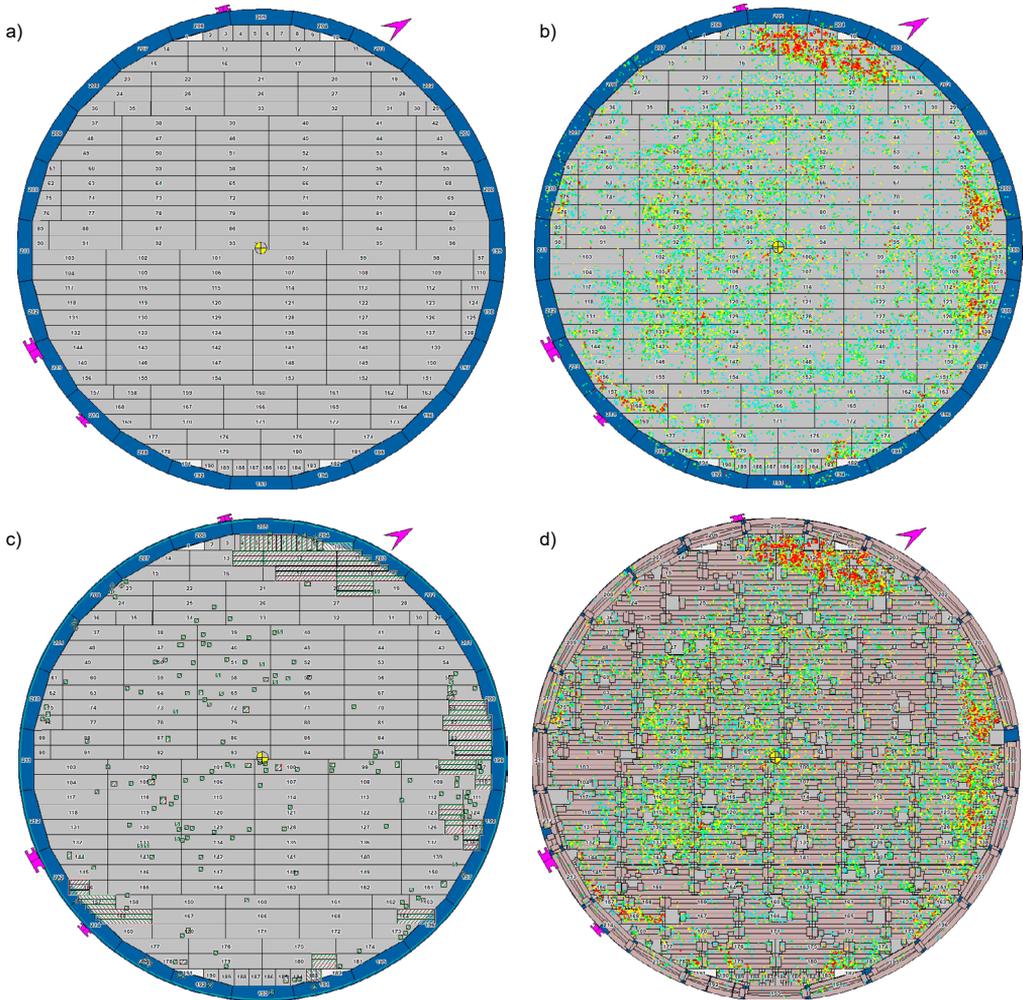
**Figure 6. Scanned bottom of the tank in the ROSOFT software**

- a) general scan visualization;
- b) identified corrosion defects;
- c) visualization of bottom plate repair/replacement;
- d) scanned bottom plates with detected anomalies

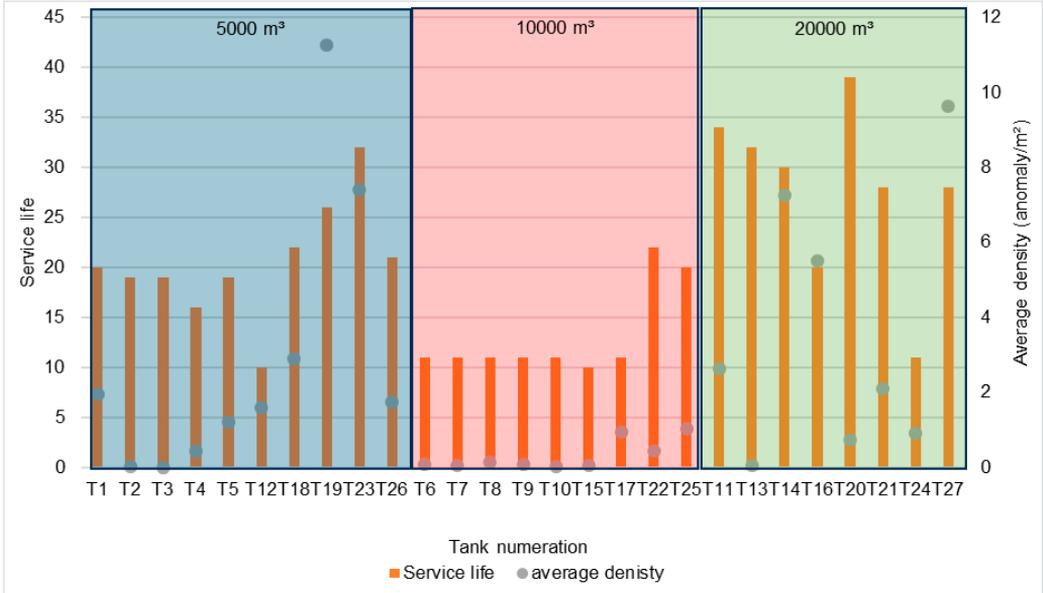
Figure 7. Analysis of service life and anomaly density in storage tanks of different capacities

In Fig. 7, the analysis reveals patterns in the relationship between tank volume, service life, and anomaly density. Smaller tanks (5000 m<sup>3</sup>) exhibit a significant variation in service life, reaching over 30 years in some cases, and are often characterized by high anomaly density, which may indicate material degradation or accumulated operational stress. Tanks with a volume of 10000 m<sup>3</sup> have relatively low anomaly density, suggesting better structural integrity at the time of inspection. However, the overall trend indicates that anomaly density increases with service life, confirming the cumulative effects of wear and aging. Larger tanks (20000 m<sup>3</sup>) demonstrate extended service lives, sometimes reaching up to 40 years, but also show the highest anomaly densities, emphasizing the correlation between longevity and structural degradation. These findings highlight the need for systematic monitoring and pre-

ventive measures, as an increase in operational time is accompanied by a rise in anomaly density, which may elevate the risk of failures and require additional safety measures.

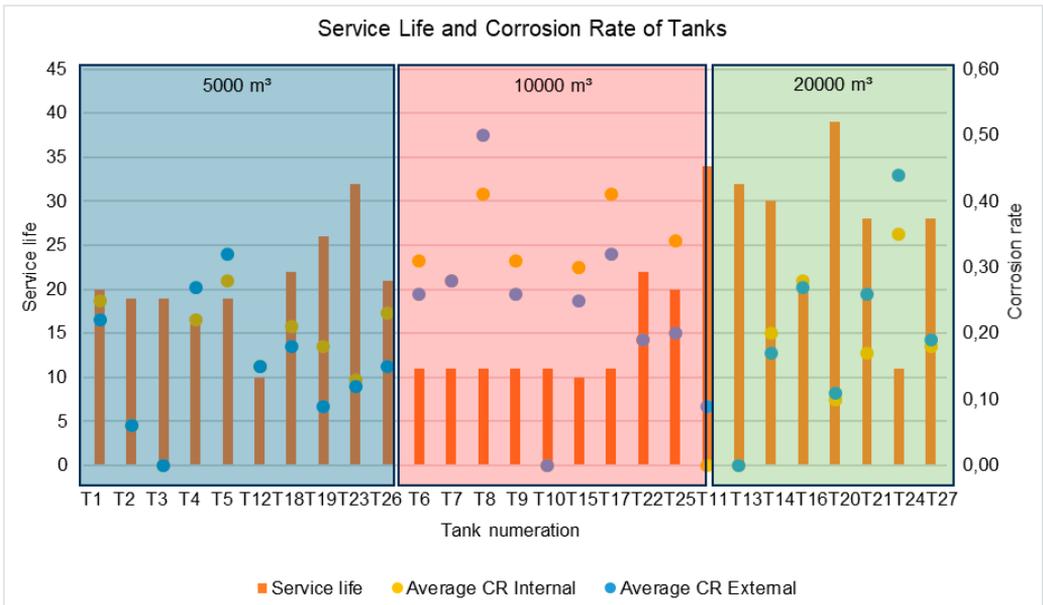
Figure 8. Service life and corrosion rate of tanks

The chart in the Fig. 8 shows the service life and corrosion rate of tanks with capacities of 5000 m<sup>3</sup>, 10000 m<sup>3</sup>, and 20000 m<sup>3</sup>. The orange bars represent service life, while the blue and purple bars indicate the average internal and external corrosion rates, respectively.

In the 5000 m<sup>3</sup> group, the service life ranges from 10 to 25 years, and the corrosion rate is distributed chaotically. In the 10000 m<sup>3</sup> category, the service life is generally lower, while the corrosion rate remains high regardless of the tank's age. The 20000 m<sup>3</sup> group shows a wider range of service life values, but young tanks often experience high corrosion rates. This data supports the conclusion that tank capacity directly influences corrosion behavior and maintenance strategies. Smaller tanks, such as those with

5000 m<sup>3</sup> capacity, experience more rapid and localized corrosion, indicating the need for frequent maintenance and more effective protective coatings. In contrast, larger tanks (10000 and 20000 m<sup>3</sup>) tend to accumulate damage more gradually over time, which makes long-term monitoring and cathodic protection systems essential. The correlation between anomaly density and the effectiveness of protective measures, particularly galvanic protection, highlights the importance of tailored maintenance strategies based on tank size and operational conditions [8, 9]. In addition, Fig. 9 shows the average service life and anomaly density across four regions: West, South, North, and Center. Higher anomaly density, as seen in the South, may contribute to faster wear. In contrast, the North region has the longest service life and the lowest anomaly density, which may indicate better operating conditions or higher-quality materials.

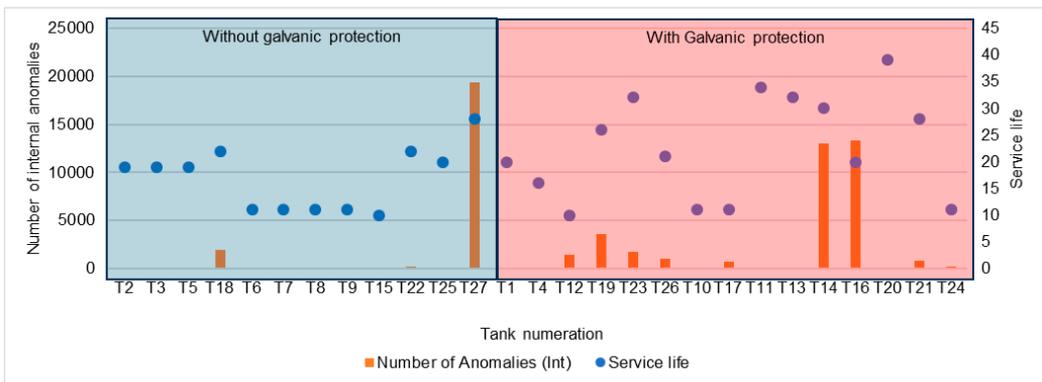
**Figure 10. Assessment of Internal Corrosion in Tanks Based on Protection Status and Operational Time**

In addition, Fig. 10 presents a comparative analysis of tanks with and without galvanic protection, showing the number of internal anomalies and the corresponding service life. The tanks on the left side, shaded in blue, represent those without galvanic protection, while those on the right side, shaded in red, are equipped with galvanic protection.

From the visual distribution of the data, there does not appear to be a strong direct correlation between the presence of galvanic protection and the number of internal anomalies. Both groups exhibit varying levels of anomalies, and the mere presence of protection does not consistently result in lower anomaly counts across all tanks.

However, a general trend can be observed in both groups: the number of internal anomalies tends to increase with the age of the tank. Especially among tanks with galvanic protection, older tanks (with longer service life) tend to show higher anom-

aly counts, suggesting that time and operational wear still contribute to internal degradation, even in the presence of protective systems. In tanks without galvanic protection, the number of anomalies is already quite high across all ages, and while the relationship with age is less clearly defined, it is evident that the lack of protection contributes to consistently higher anomaly levels overall.

This indicates that while galvanic protection may mitigate corrosion or degradation to some extent, it does not eliminate the long-term effects of aging, and the accumulation of anomalies over time is still significant factor regardless of protection status.
