# Evaluating Integrity of Storage Tank Bottoms based on Advanced MFL/ET Scanning: Use Case in Kazakhstan

Daniyar A. Ualiyev<sup>1</sup>, Abdugaffor Mirzoev<sup>2</sup>

## ABSTRACT

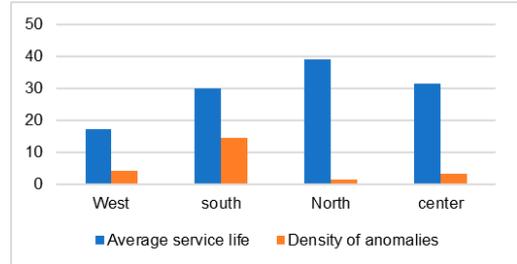
**Figure 9. Average service life and anomaly density by region**

5000 m<sup>3</sup> capacity, experience more rapid and localized corrosion, indicating the need for frequent maintenance and more effective protective coatings. In contrast, larger tanks (10000 and 20000 m<sup>3</sup>) tend to accumulate damage more gradually over time, which makes long-term monitoring and cathodic protection systems essential. The correlation between anomaly density and the effectiveness of protective measures, particularly galvanic protection, highlights the importance of tailored maintenance strategies based on tank size and operational conditions [8, 9]. In addition, Fig. 9 shows the average service life and anomaly density across four regions: West, South, North, and Center. Higher anomaly density, as seen in the South, may contribute to faster wear. In contrast, the North region has the longest service life and the lowest anomaly density, which may indicate better operating conditions or higher-quality materials.

However, a general trend can be observed in both groups: the number of internal anomalies tends to increase with the age of the tank. Especially among tanks with galvanic protection, older tanks (with longer service life) tend to show higher anom-

aly counts, suggesting that time and operational wear still contribute to internal degradation, even in the presence of protective systems. In tanks without galvanic protection, the number of anomalies is already quite high across all ages, and while the relationship with age is less clearly defined, it is evident that the lack of protection contributes to consistently higher anomaly levels overall.

This indicates that while galvanic protection may mitigate corrosion or degradation to some extent, it does not eliminate the long-term effects of aging, and the accumulation of anomalies over time is still significant factor regardless of protection status.
